RE: Possible Illicit Discharge of Sewage into the Under Air Rights Garage, New Haven, CT

August 12, 2013

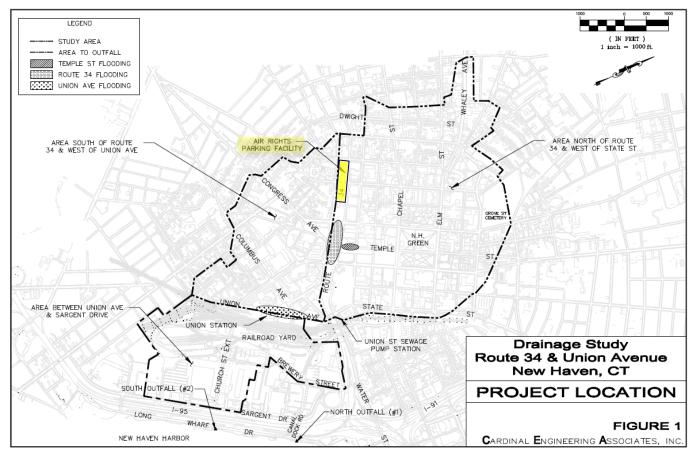
The study area of the Cardinal report includes a drainage basin of 580 acres in downtown New Haven and includes Yale New Haven Hospital (YNHH), Smilow Cancer Hospital (SCH), the Temple St. Garage, the Union Avenue Garage, and the Air Rights Garage (ARG). As seen in Fig. 2, the ARG is just upstream of the area designated ROUTE 34 FLOODING. The flooding that occurs in the areas designated as TEMPLE ST FLOODING and UNION AVE FLOODING include two parking garages (Temple St & Union Ave) that are operated by the New Haven Parking Authority (NHPA). What is conspicuolusly absent from the Cardinal report is an account of the recurrent flooding that also occurs in an additional parking space operated by the NHPA, the Under Air Rights Garage (UARG, Fig. 3).

Fig. 2. Please note that this map is rotated approximately 90 degrees clockwise. The actual long axis of the ARG is oriented more east-westerly.

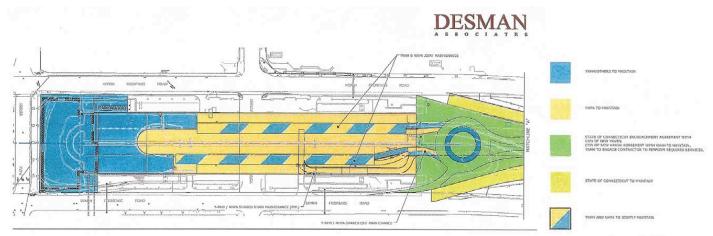
In addition to the GNHWPCA, it is my opinion that the NHPA and YNHH should also share responsibility for the flooding. As shown in Fig. 14 below, the maintenance of the UARG is shared by YNHH and the NHPA. Furthermore, it is not clear whether YNHH is aware that is is operating a loading dock with an access road, and egress, that can be inundated with untreated sewage.

Fig. 14. Map depicting shared maintenance responsibilities in the UARG, and for the loading dock and roundabout just east of the ARG.
